Structural Maintenance of the Tension Structure Roof - Rome Olympic Stadium

Summary

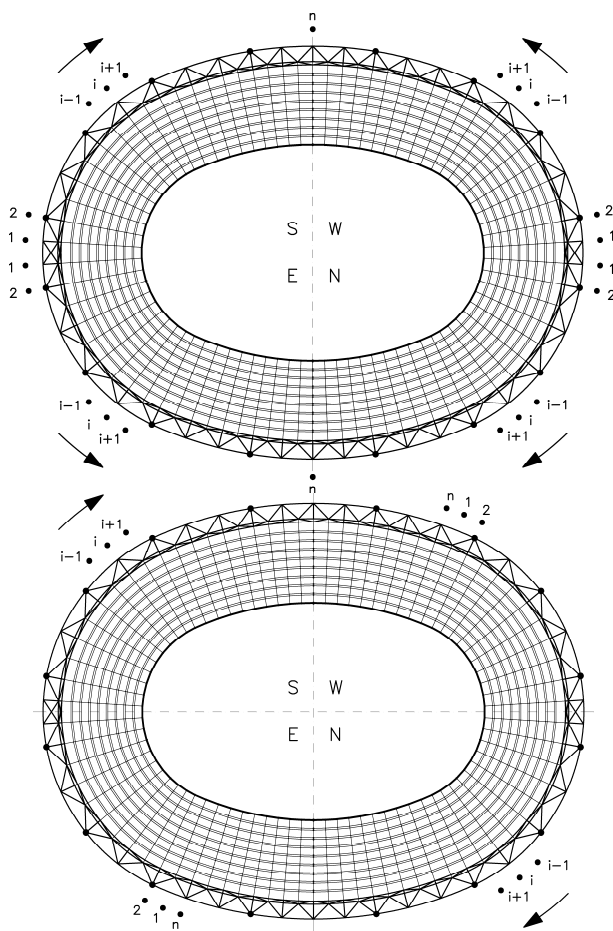
Loss of pre-stress forces, due to the creep of the cables, appeared from the monitoring, with reduction of the forces in the radial cable beams to values lower than the design pre-stress; in a conservative approach and wanting to preserve the stiffness characteristics of the structure, it has been decided to carry out re-tensioning operations. The first re-tensioning was done after 7 years from the construction and a second after 17 years.

Figure 5: Scheme of re-tensioning sequences 4 fronts or 2 fronts

To carry out the re-tensioning in a consistent way, the following sequence of operation has been adopted:

- general survey of the forces at the cable anchorages
 - general survey of the geometry
 - simulation, on numerical model, of the structure with the actual dispersed values of the forces measured; a specially in house developed numerical procedure, integrated in the numerical analysis software, has been used to reproduce with sufficient precision the surveyed force condition

- simulation, on numerical model, of the re-tensioning operation, carried out in several steps, operating in symmetry on the construction, with determination at each step of the force variation to be applied to the cable anchorage operated at the step, of the extension at the anchorage, of the force variation in all the other cables, of the geometry variation at all the joints; the Figure 5 shows two possible symmetries of sequence adopted, with 4 fronts on the 4 opposite sectors or 2 fronts on 2 opposite sectors, in rotation around the construction

- execution of the re-tensioning, acting with different teams, with the designed sequence; during the sequence the measured forces and extension, as well as the geometry variation are registered and compared with the theoretical values from the model

- at the end of the sequences, measurement of the forces on sample cables in the different sectors and general geometrical survey
- We have observed that the distribution and variation of the forces is rather accurate and near to that predicted by the numerical model; the general displacements have the same behaviour but with smaller values; the reason of the smaller displacements can be interpreted as higher global stiffness

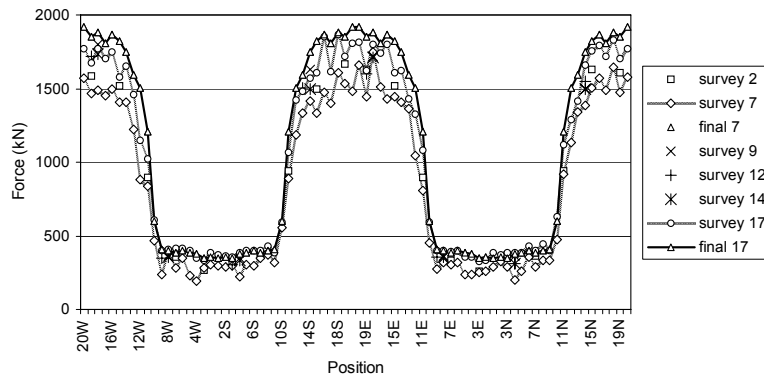
Figure 7: Measured forces in the stabilising cables

The diagrams of the forces measured on site are shown in the Figure 7 and Figure 8 and the average force ratios from the measurements are given in the Table 2

There is a dispersion of the measured data, reasonably due also to the initial tolerances during construction, to measurements precision and to differences of configuration as example for thermal effects.

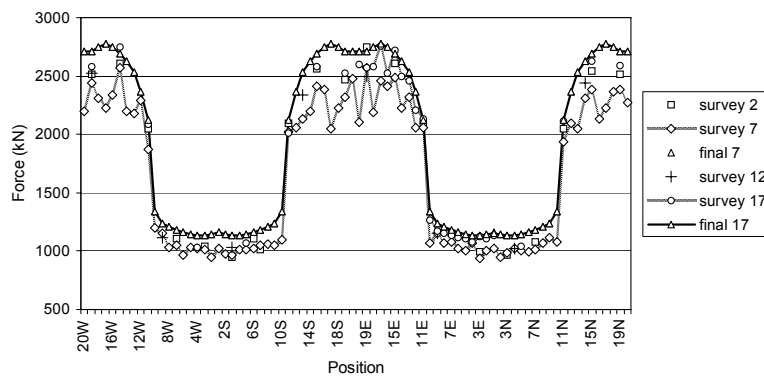
Figure 8: Measured forces in the carrying cables

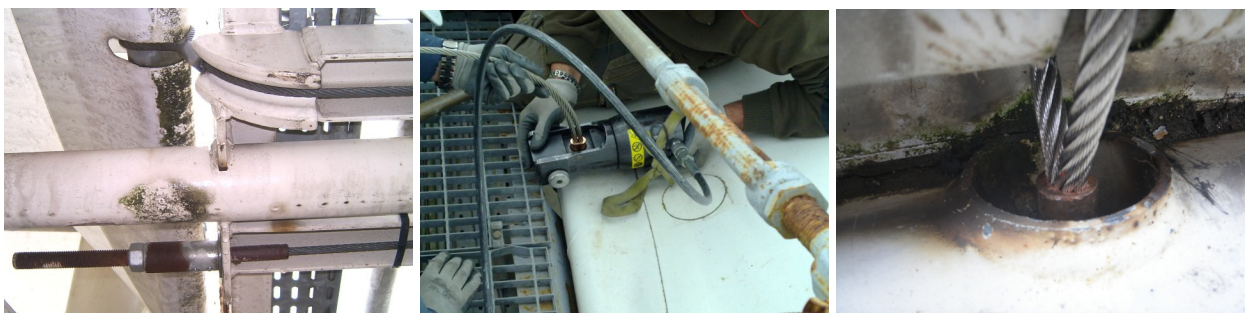
Figure 9: Corroded wire ropes, replacement with stainless steel wire ropes

Other components that were found subject to corrosion, are small wire ropes that hold in tension the membrane panels pulling their edge pipes (Figure 9); at the construction the material used for these small components with diameter 8 mm was hot dip galvanised steel. After about 10 years, in the exposition to the rainwater, with the pollution from the urban traffic, the zinc coating appeared deteriorated and oxidised, and after some more years extended corrosion affecting the wire ropes

and their sockets was detected. Specially in zones subjected to water traps, a quantity of wires were completely corroded and a complete replacement is carried out, after 20 years. The new elements installed are stainless steel wire ropes, with stainless steel swaged socket and nut, with copper ferrule; the diameter of the new wire ropes has been increased to 10 mm, to have, with a material that has a little lower mechanical properties, a strength higher than the initial. Also for the replacement of these components it has been necessary to define a method and a sequence of operation that allows to maintain in full operation the structure during all the works, without dismantling complete panels of membrane, that would limit the access to some zones of the stands during the works. The replacement is done one by one, with de-tensioning and cutting of the old rope, installation of the new one, with swaging of the ferrule on site and then re-tensioning. This work is done from the permanent catwalks, with some additional provision for the access.

- use materials with intrinsic anticorrosion, specially on small elements; long term protection provided by coatings should be maintainable; galvanised surfaces should be overcoated;

- small and medium wire ropes and spiral strands should be made by stainless steel;
- bolts should be made by stainless steel where possible for the steel grade required, specially for small sizes; where stainless steel is not possible, hot dip galvanised elements should be used, with additional coating applied after the installation;
