Structural Maintenance of the Tension Structure Roof - Rome Olympic Stadium

Summary

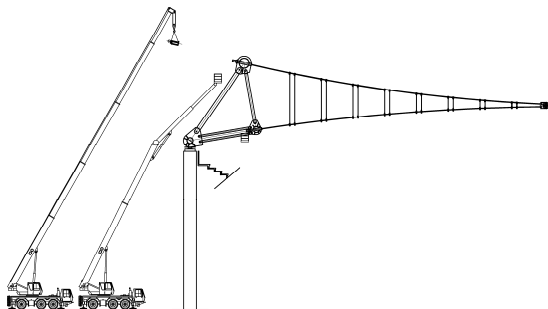
Figure 3: Access with cranes for jacks

As the on-site measuring operation, specially for the forces in the cables, is demanding, with heavy jacking equipment used at height (Figure 3), to optimise the cost and efficiency of the monitoring the force surveys have been carried out on different samples in the years following the construction.

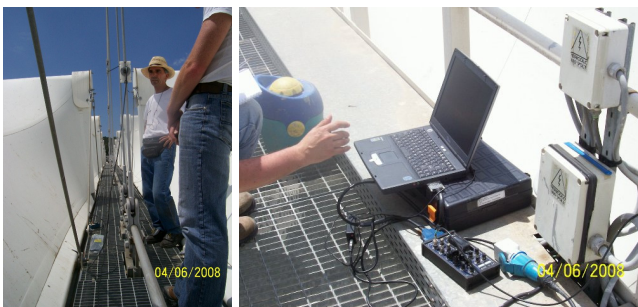
Figure 4: Dynamic measurement of natural frequencies for the force determination

The force measurement was made also on the inner ring cables, that are spliced to form a continuous ring, with no jacking accommodation in the end termination, by dynamic vibration

method. The results, obtained by the measurement of the free vibration frequencies of segments of cables between the clamps, have provided force estimates coherent with the values obtained by the other measurements and this method appears suitable to be used for comparison and for the monitoring of the global pre-stressing force variation, when carried out at successive time intervals.

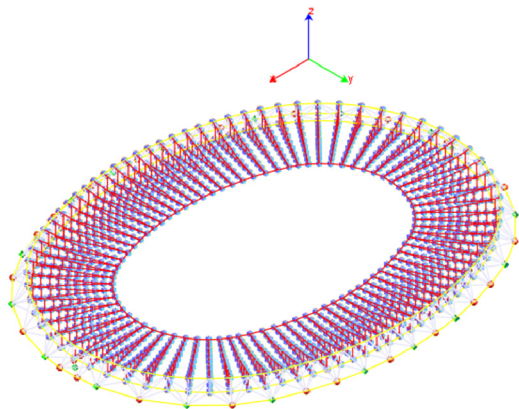
Figure 6: Numerical model scheme

Different creep conditions have been analysed on numerical models (Figure 6); for the particular case the permanent force in a set of stabilising cables in the zone of low curvature of the inner tension ring is rather low, and the simulation of the creep, at higher levels, generates singularities in the numerical model

due to slackening. To avoid singularities and trying to follow a possible physical behaviour of the structure, the following conditions have been simulated, including some cases to check the effect of higher creep in the inner tension ring:
